UNDERSTANDING DIAPHRAGM FAILURES

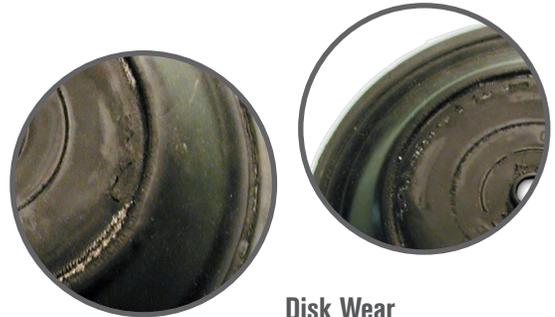
On the liquid side of the diaphragm, there will be an abrasion ring worn where the diaphragm meets the outer disk. Life of the diaphragm will dictate whether the abrasion is excessive; as some wear is normal. The pumps are rated to 40% by weight solids, however, when this is exceeded or when solids are particularly sharp (i.e. silica slurry) this type of failure is more common. Maintaining a good flushing system, paying attention to the % solids, using an abrasion pad and/or slowing down fluid velocities will help.

Note: If a diaphragm is torn dramatically along the bottom side and there is bending of the center shafts, this is definitely a solids settling issue and should be addressed accordingly.

Disk Wear

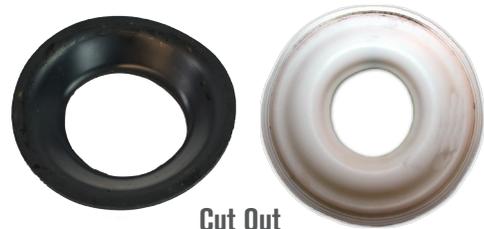
In this case, there will be a pronounced cut line around the center of the diaphragm where the outer or inner disk comes into contact with the diaphragm. When the center disks are installed it is important to make sure that the round edges face the diaphragm to avoid a dramatic cutting effect. Additionally, if the diaphragm is installed backwards, you will notice the same dramatic cut around the center disk of the diaphragm. Either failure will drastically shorten the life of the diaphragm.

Cut Out

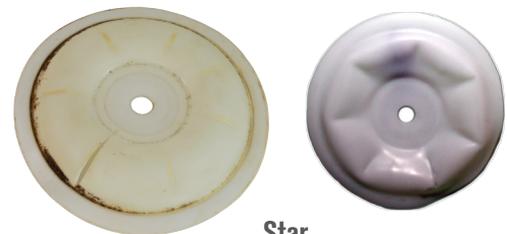
A diaphragm that has been dry run too much or too often will have a star-like wear pattern starting at the center, extending outward, and the diaphragm life will be abnormally short. To avoid this situation, use the proper operation with liquid level controllers, dry run detectors, speed control mufflers and/or by simply operating the system to avoid dry running. The pump will not self-destruct when dry run, however, the diaphragm does have a life cycle, whether there is liquid present or not. When the pump is run, with the presence of liquid or not, the diaphragm life is being consumed. This is compounded by a dry run situation, putting uneven pressure on the diaphragm and allowing for over speeding of the pump.

Star Pattern

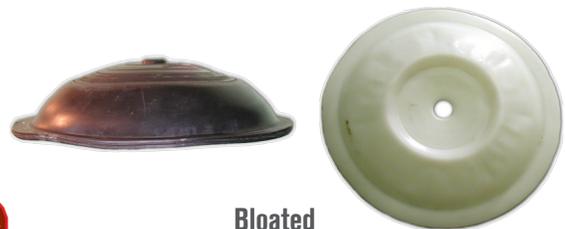
The diaphragm will have a bloated appearance toward the liquid chamber. The bloating is caused by uneven pressure on the diaphragm. In this type of failure, the air pressure is greatly exceeding the required discharge pressure. A common cause of this is the opening up of the ball valve, allowing the pump to run wide open before being fully primed. It is not recommended to pressurize the system, in order to check for functionality, or to fully open up the air pressure before it is primed.

Bloated
