WOODFORD MANUFACTURING COMPANY

Y34, Y1 or Y2 Yard Hydrant Packing Replacement

Rev 06/15 Form No.TMYH-1.104

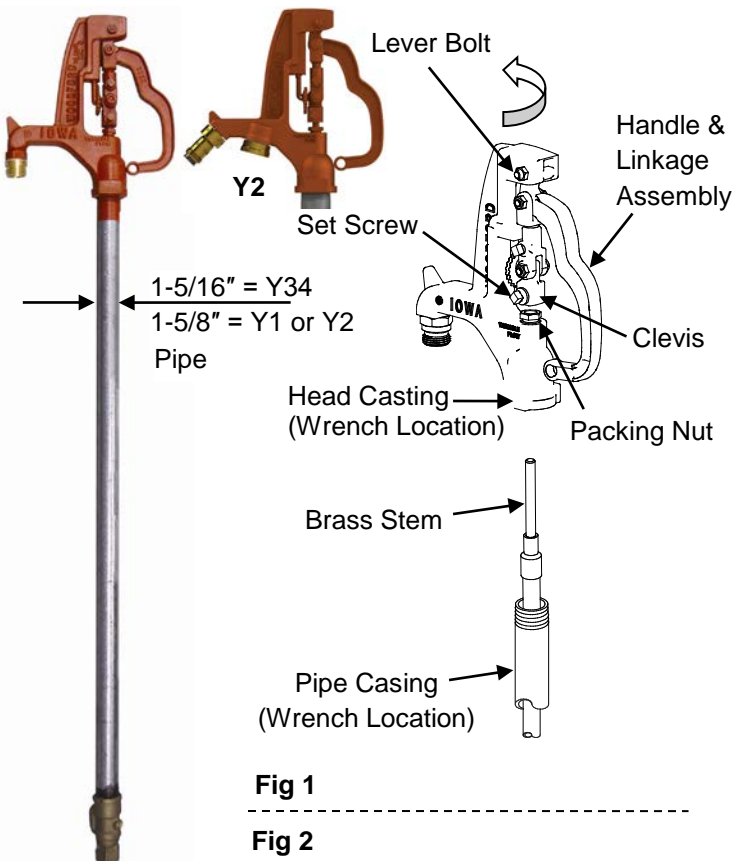
1. Shut off water supply to hydrant.
2. Loosen the Clevis Set Screw. Fig 1
3. Loosen, *do not remove*, the Packing Nut. Fig 1
4. Remove head casting using two pipe wrenches, one on head casting and the other on the pipe. Fig 1

5. Remove the Lever Bolt and remove and set aside the Handle and Linkage Assembly. Fig 1
6. Remove the Packing Nut. Fig 2
7. Dig out the graphite Packing with a screwdriver or other instrument. **Note:** This operation will destroy the Packing and require a new Packing #10101.

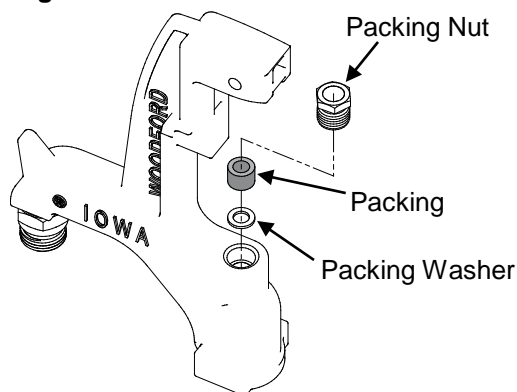
Fig 2

8. The Packing Washer #10102 may be reused.
9. Install new Packing #10101.
10. Reinstall the Packing Nut - do not tighten.
11. Reinstall the Handle and Linkage Assembly.
