Replacing

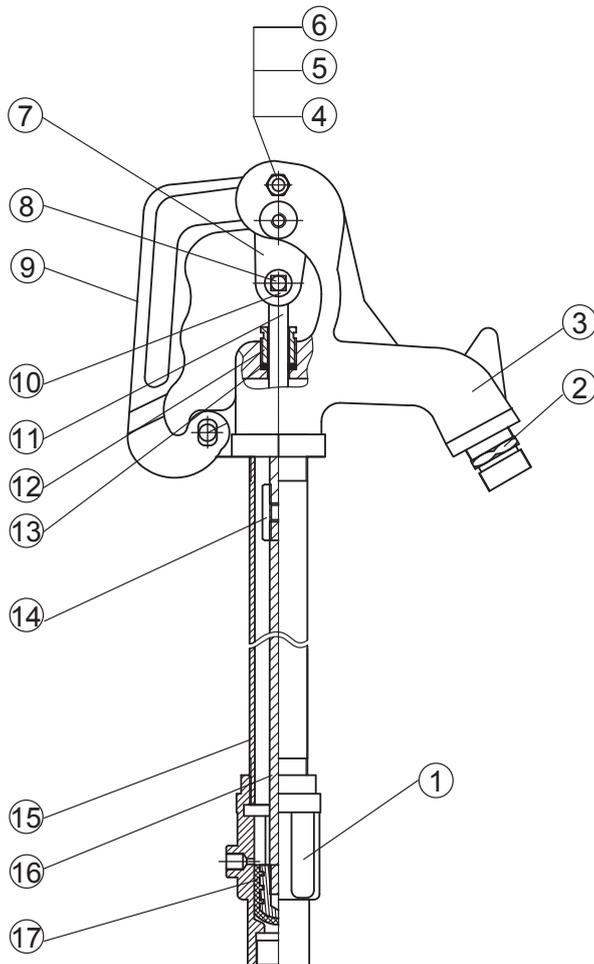
- Step 1. TURN WATER SUPPLY OFF! OPEN HYDRANT TO RELIEVE PRESSURE.
- Step 2. Loosen the SQUARE HEAD SET SCREW(8).
- Step 3. Unscrew the head (Key No. 3) from pipe (15).

- Step 4. Unscrew the clevis rod (Key No. 11) and coupling nut (14), remove old Head Assembly.
- Step 5. Loosen the SQUARE HEAD SET SCREW on the new Complete Head Assembly.

- Step 6. Wrap the pipe thread(15) with 2-3 turns of teflon tape.
- Step 7. Screw the coupling nut (14) on the new Complete Head Assembly to the inner rod on the old.

- Step 8. Screw the new Complete Head Assembly to the pipe(15).
- Step 9. Hydrant adjustment procedure.
 - 9.1. Push brass rod down as far as it will go (by hand) to be sure that the plunger is touching the seat.

- 9.2. Move handle open approximately 30 degrees from closed position.
 - 9.3. Tighten setscrew snugly.
 - 9.4. Turn water supply on.
 - 9.5. Operate hydrant and make sure the hydrant is shutting off properly and flowing properly.

- 9.6. If hydrant still does not shut off,repeat steps 9.1 thru 9.5.
 - 9.7. Flow water through hydrant and then close completely to check for proper drainage by:

- A. Listening for water draining down the pipe; or
 - B. Putting your hand over the hose connection to feel for a vacuum; if hydrant does not drain, see step 8.

- 9.8. To clear drain hole blockage,close off hydrant spout by using hose cap or by attaching and kinking a hose. Open and close hydrant to allow water pressure to clear blockage. Repeat step 9.7 to verify proper drainage. If hydrant still does not drain, repeat steps 9.1 thru 9.7 to fully uncover drain hole.

CAUTION: DO NOT TRY TO ADJUST ALL AT ONCE OR YOU MAY OVERADJUST AND CAUSE DAMAGE TO THE PLUNGER. FOR THIS REASON. ADJUST IN SMALL INCREMENTS.

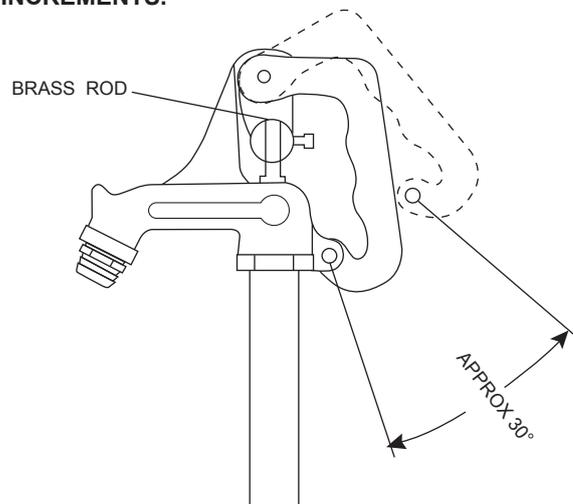
ITEM	QTY	DESCRIPTION
17	1	PLUNGER
16	1	INNER ROD
15	1	PIPE
14	1	COUPLING NUT
13	2	O RINGS
12	1	PACKING NUT
11	1	CLEVIS ROD
10	1	CONNECTOR
9	1	HANDLE
8	1	SQUARE HEAD SET SCREW
7	2	LINKAGE
6	1	SNAP WASHER
5	1	NUT
4	1	BOLT
3	1	HEAD
2	1	HOSE ADAPTER
1	1	FOOT VALVE

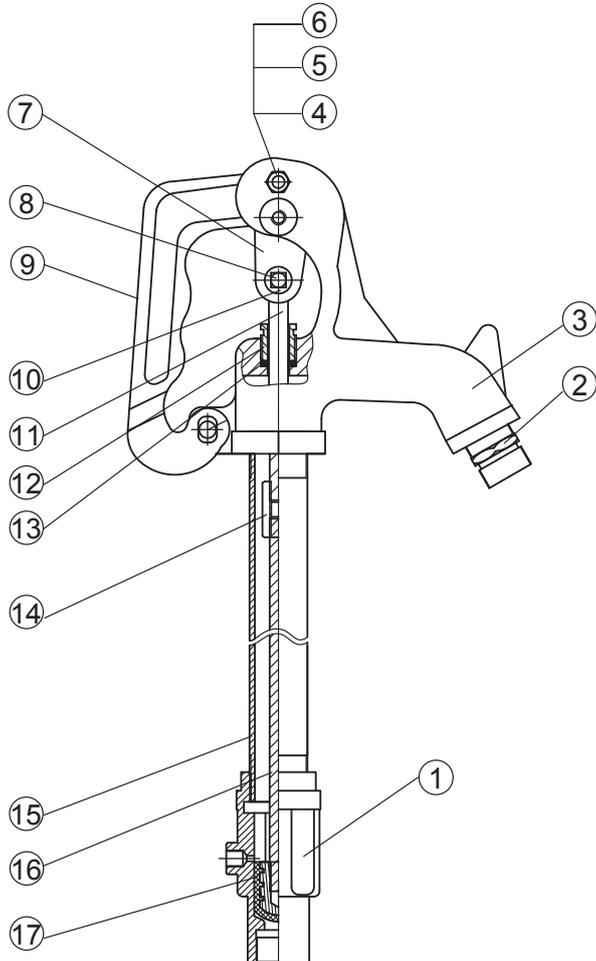
- Step 1. TURN WATER SUPPLY OFF! OPEN HYDRANT TO RELIEVE PRESSURE.**
- Step 2. Loosen the SQUARE HEAD SET SCREW(8).**
- Step 3. Unscrew the head (Key No. 3) from pipe (15).**

- Step 4. Unscrew the clevis rod (Key No. 11) and coupling nut (14), remove old Head Assembly.**
- Step 5. Loosen the SQUARE HEAD SET SCREW on the new Complete Head Assembly.**

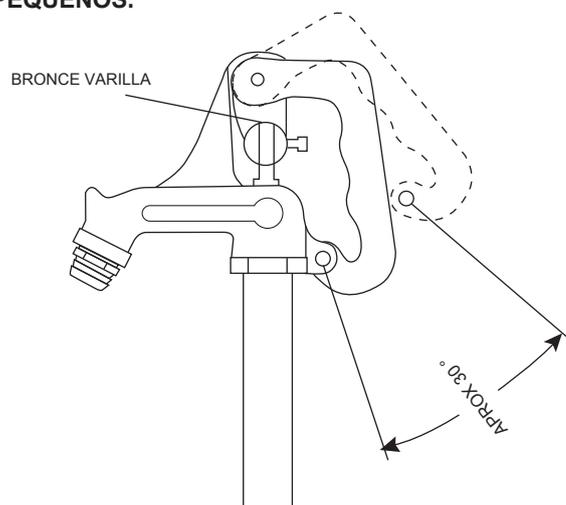
ARTÍCULO	CANTIDAD.	DESCRIPCIÓN
17	1	ÉMBOLO
16	1	VARILLA INTERNA
15	1	TUBO
14	1	TUERCA DE ACOPLAMIENTO
13	2	JUNTA TÓRICA
12	1	TUERCA DE EMPAQUE
11	1	BARRA DE LA HORQUILLA
10	1	CONECTOR
9	1	MANIJA
8	1	TORNILLO DE FIJACIÓN DE CABEZA CUADRADA
7	2	ENLACE
6	1	LAVADORA A PRESIÓN
5	1	TUERCA
4	1	TORNILLO
3	1	CABEZA
2	1	ADAPTADOR DE LA MANGUERA
1	1	VÁLVULA DE PIE

- Step 6. Wrap the pipe thread(15) with 2-3 turns of teflon tape.**
- Step 7. Screw the coupling nut (14) on the new Complete Head Assembly to the inner rod on the old.**

- Step 8. Screw the new Complete Head Assembly to the pipe(15).**
- Step 9. Hydrant adjustment procedure.**
- 9.1. Push brass rod down as far as it will go (by hand) to be sure that the plunger is touching the seat.
